Rehabilitating Peripheral Health Units to Save Lives

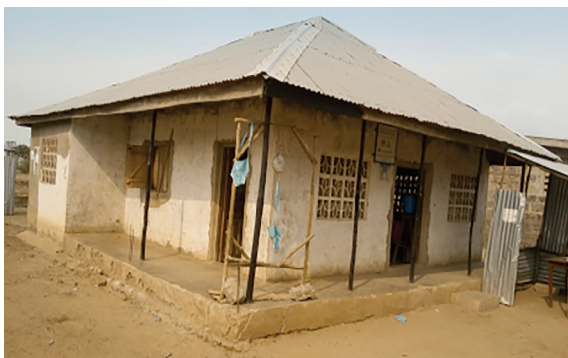
Benguima Grassfield Maternal and Child Health Post before renovation.

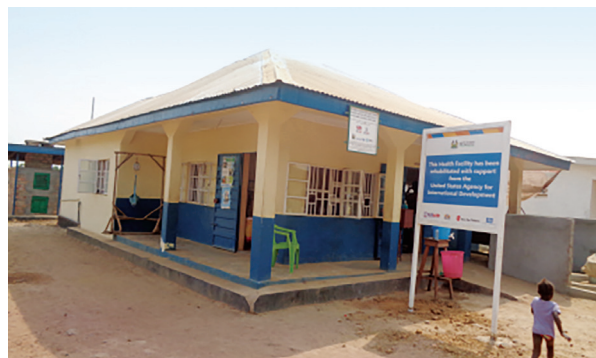
Benguima Grassfield Maternal and Child Health Post after renovation.

PHU building upgrades and repairs included ceilings, roofs (new corrugated iron sheeting), walls, floors, painting, handicap accessibility, stencils to indicate the type of room in the facility, improvements to windows and doors for security, and provision of medical equipment and non-clinical furniture.
